**5 Lochy Crescent  
Inverlochy  
Fort William  
PH33 6NG**

Inspected on: 5<sup>th</sup> August 2019

**Prepared by:**  
Samuel & Partners  
First Surveyors Scotland  
44 High Street  
FORT WILLIAM  
PH33 6AH

# Home Report index

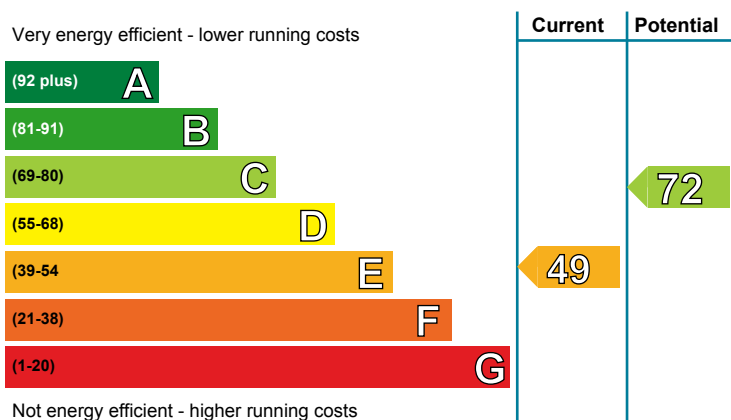
## Energy Efficiency Rating

This graph shows the current efficiency of your home, taking into account both energy efficiency and fuel costs. The higher this rating, the lower your fuel bills are likely to be.

Your current rating is **band E (49)**. The average rating for EPCs in Scotland is **band D (61)**.

The potential rating shows the effect of undertaking all of the improvement measures listed within your recommendations report.

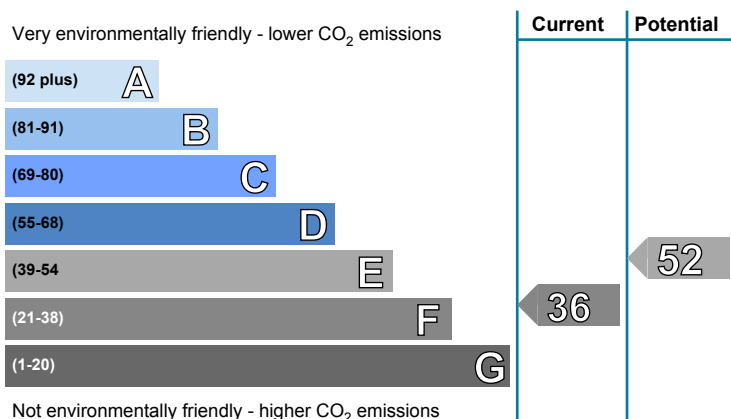
## Environmental Impact (CO<sub>2</sub>) Rating

This graph shows the effect of your home on the environment in terms of carbon dioxide (CO<sub>2</sub>) emissions. The higher the rating, the less impact it has on the environment.
