single survey

survey report on:

Property address	30 St Albans Road Edinburgh
	EH9 2LU

Prepared by	Graham + Sibbald Chartered Surveyors
-------------	--------------------------------------

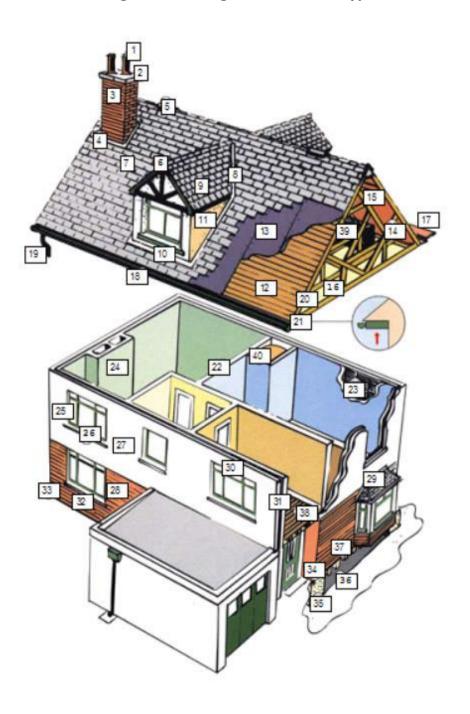
Sectional Diagram showing elements of a typical house

- Chimney pots
- Coping stone
- 3 Chimney head
- 4 Flashing
- Ridge ventilation 5
- 6 Ridge board
- Slates/tiles
 - Valley guttering
- 8 9 Dormer projection
- 10 Dormer flashing
- 11 Dormer cheeks
- 12 Sarking
- 13 Roof felt
- 14 Trusses
- 15 Collar
- 16 Insulation
- 17 Parapet gutter
- 18 Eaves guttering
- 19 Rainwater downpipe 20
- Verge boards / skews 21
 - Soffit boards
- 22 Partition wall
- 23 Lath / plaster
- 24 Chimney breast
- 25 Window pointing
- 26 Window sills
- 27 Rendering
- 28 Brickwork / pointing
- 29 window Bay
 - projection
- 30 Lintels
- Cavity walls / wall ties
- 32 Subfloor ventilator
- 33 Damp proof course
- 34 Base course
- 35 **Foundations**
- 36 Solum
- 37 Floor joists
- 38 Floorboards
- 39 Water tank
- 40 Hot water tank

Reference may be made in this report to some or all of the above component parts of the property. This diagram may assist you in locating and understanding these items.
