YOUR ONESURVEY
HOME REPORT

3/1
4 Breadalbane Street
Glasgow
G3 7BN

SINGLE SURVEY

Single Survey

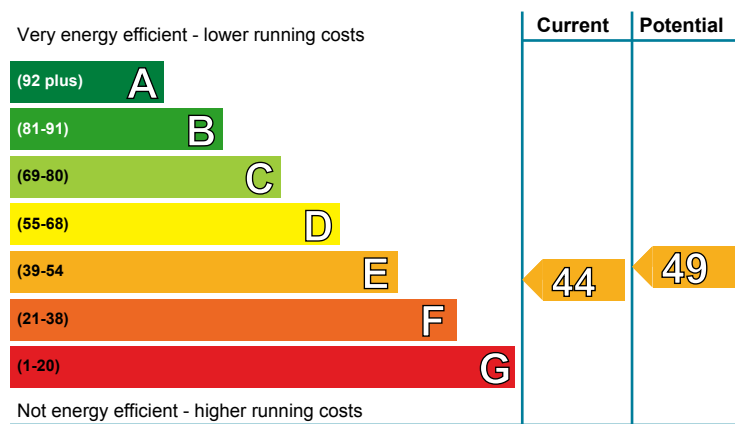
Energy Efficiency Rating

This graph shows the current efficiency of your home, taking into account both energy efficiency and fuel costs. The higher this rating, the lower your fuel bills are likely to be.

Your current rating is **band E (44)**. The average rating for EPCs in Scotland is **band D (61)**.

The potential rating shows the effect of undertaking all of the improvement measures listed within your recommendations report.

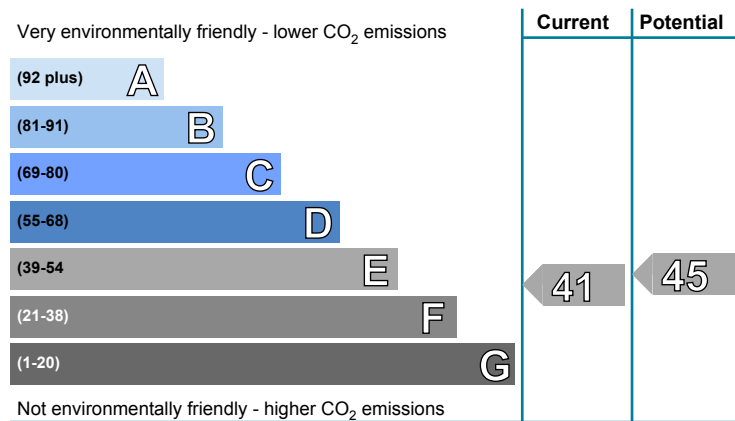
Environmental Impact (CO₂) Rating

This graph shows the effect of your home on the environment in terms of carbon dioxide (CO₂) emissions. The higher the rating, the less impact it has on the environment.
