YOUR ONESURVEY  
**HOME REPORT**

8 Boclair Crescent  
Bearsden, Glasgow  
G61 2AG

# SINGLE SURVEY

A report on the condition of the property, with categories being rated from 1 to 3.

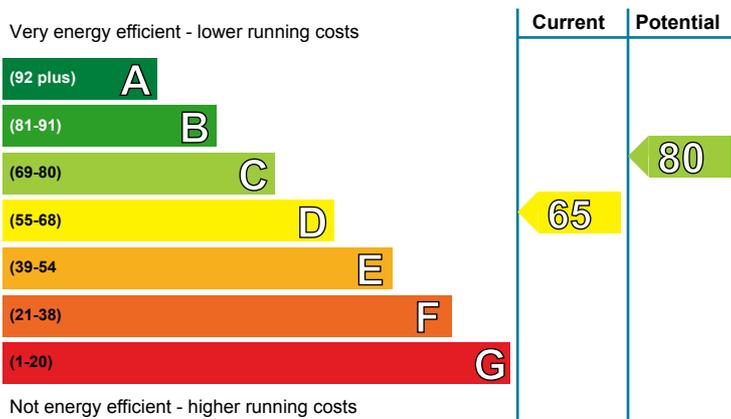
## Energy Efficiency Rating

This graph shows the current efficiency of your home, taking into account both energy efficiency and fuel costs. The higher this rating, the lower your fuel bills are likely to be.

Your current rating is **band D (65)**. The average rating for EPCs in Scotland is **band D (61)**.

The potential rating shows the effect of undertaking all of the improvement measures listed within your recommendations report.

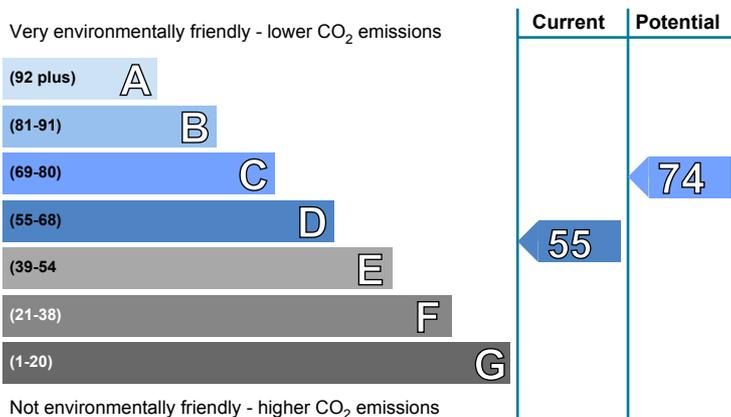
## Environmental Impact (CO<sub>2</sub>) Rating

This graph shows the effect of your home on the environment in terms of carbon dioxide (CO<sub>2</sub>) emissions. The higher the rating, the less impact it has on the environment.
