# **HOME REPORT**

FLAT 1 34 SPEIRS WHARF GLASGOW G4 9TG

# SINGLE SURVEY

# survey report on:

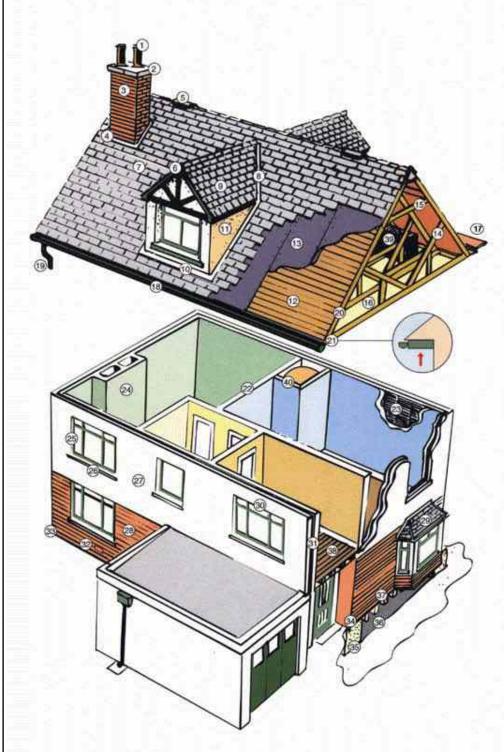
#### Sectional Diagram showing elements of a typical house

Reference may be made in this report to some or all of the above component parts of the property. This diagram may assist you in locating and understanding these items.

- 1) Chimney pots
- (2) Coping stone
- 3) Chimney head
- 4) Flashing
- (5) Ridge ventilation
- 6) Ridge board
- 7) Slates / tiles
- (8) Valley guttering
- 9) Dormer projection
- 10 Dormer flashing
- 11) Dormer cheeks
- (12) Sarking
- (13) Roof felt
- (14) Trusses
- 15) Collar
- (16) Insulation
- 7) Parapet gutter
- 18) Eaves guttering
- 19) Rainwater downpipe
- 0) Verge boards /skews
- 21) Soffit boards
- 22) Partition wall
- 23) Lath / plaster
- Latin / plaster
- (24) Chimney breast
- 25) Window pointing
- 26) Window sills
- (27) Rendering
- (28) Brickwork / pointing
- 29) Bay window projection
- (30) Lintels
- (31) Cavity walls / wall ties
- 32) Subfloor ventilator
- 33) Damp proof course
- 34) Base course
- 35) Foundations
- 36) Solum
- 37) Floor joists
- 38) Floorboards
- 9) Water tank
- 10) Hot water tank
