SINGLE SURVEY REPORT

PROPERTY ADDRESS	Ballengeich House 21 Erskine Place Pumpherston Livingston EH53 0LU
CLIENT	Peter Hellston
CLIENT ADDRESS	Ballengeich House 21 Erskine Place Pumpherston Livingston EH53 0LU
DATE OF INSPECTION	21 August 2020
PREPARED BY	DIXON HEANEY KEAN KENNEDY Chartered Surveyors 54 Corstorphine Road Edinburgh EH12 6JQ Tel: 0131 313 0444 Fax: 0131 313 0555 Email: survey@dhkk.co.uk

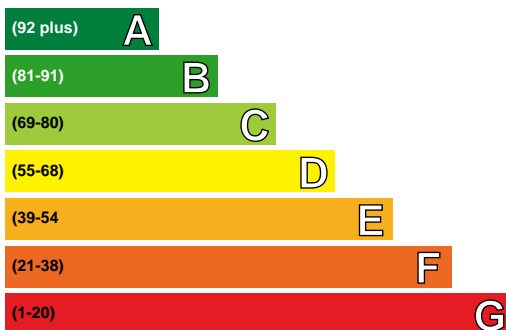
* based upon the cost of energy for heating, hot water, lighting and ventilation, calculated using standard assumptions

Very energy efficient - lower running costs

Not energy efficient - higher running costs

Current	Potential
53	87

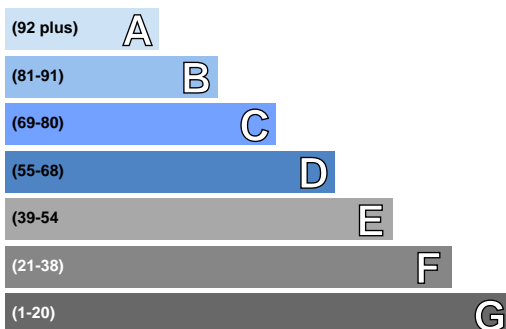
Very environmentally friendly - lower CO₂ emissions

Not environmentally friendly - higher CO₂ emissions

Current	Potential
48	83
