# Home Report

### 37 QUALITY STREET, EDINBURGH, EH4 5BP

Dwelling type: Ground-floor flat
Date of assessment: 08 September 2020
Date of certificate: 11 September 2020

# Scottish Single Survey

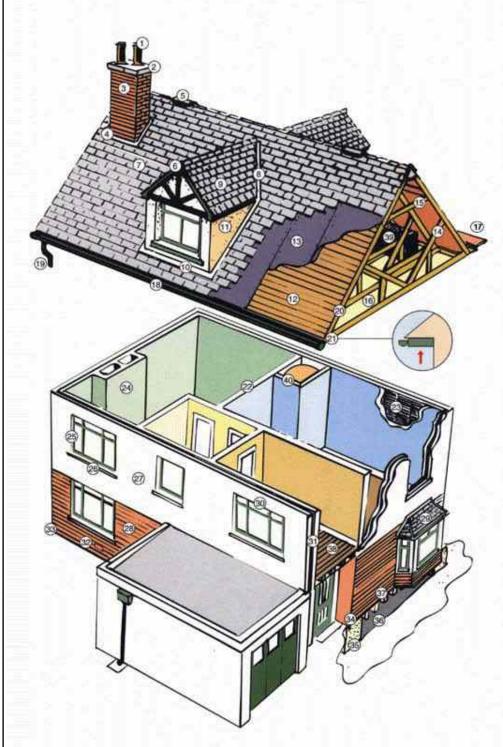
## Sectional Diagram showing elements of a typical house

Reference may be made in this report to some or all of the above component parts of the property. This diagram may assist you in locating and understanding these items.

- 1 Chimney pots
- 2 Coping stone
- 3) Chimney head
- 4) Flashing
- 5 Ridge ventilation
- 6) Ridge board
- 7) Slates / tiles
- (8) Valley guttering
- 9 Dormer projection
- 10 Dormer flashing
- 11) Dormer cheeks
- (12) Sarking
- 13) Roof felt
- (14) Trusses
- 15) Collar
- (16) Insulation
- 7) Parapet gutter
- 18) Eaves guttering
- (19) Rainwater downpipe
- 0) Verge boards /skews
- (21) Soffit boards
- 22) Partition wall
- 23) Lath / plaster
- (24) Chimney breast
- 25) Window pointing
- (26) Window sills
- (27) Rendering
- (28) Brickwork / pointing
- (29) Bay window projection
- (30) Lintels
- (31) Cavity walls / wall ties
- 32) Subfloor ventilator
- 33) Damp proof course
- 34) Base course
- 35) Foundations
- 36) Solum
- 37) Floor joists
- 38) Floorboards
- 9) Water tank
- 40) Hot water tank
