the home report

survey report on:

Property address	The Coach House St Germains LONGNIDDRY EH32 0PQ	
Customer	Mr and Mrs Penman	
Customer address	The Coach House St Germains LONGNIDDRY EH32 0PQ	
Prepared by	ALLIED SURVEYORS SCOTLAND PLC	
Date of inspection	10th July 2020

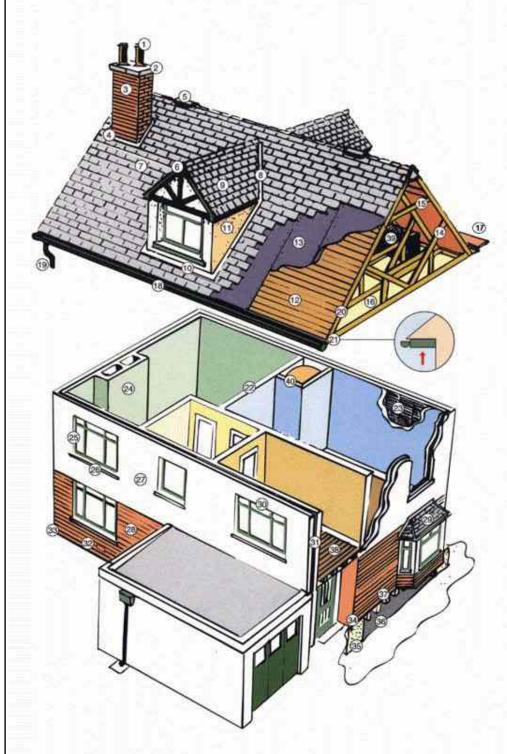
Sectional Diagram showing elements of a typical house

Reference may be made in this report to some or all of the above component parts of the property. This diagram may assist you in locating and understanding these items.

- 1 Chimney pots
- 2 Coping stone
- 3) Chimney head
- 4) Flashing
- (5) Ridge ventilation
- 6) Ridge board
- 7) Slates / tiles
- (8) Valley guttering
- 9 Dormer projection
- (10) Dormer flashing
- 11) Dormer cheeks
- (12) Sarking
- 13) Roof felt
- (14) Trusses
- 15) Collar
- (16) Insulation
- 17) Parapet gutter
- 18) Eaves guttering
- 19) Rainwater downpipe
- Verge boards /skews
- (21) Soffit boards
- 22) Partition wall
- 23) Lath / plaster
- co Latir/ plaster
- (24) Chimney breast
- 25) Window pointing
- 26 Window sills
- (27) Rendering
- (28) Brickwork / pointing
- 29) Bay window projection
- (30) Lintels
- (31) Cavity walls / wall ties
- 32) Subfloor ventilator
- 33) Damp proof course
- (34) Base course
- 35) Foundations
- 36) Solum
- 37) Floor joists
- 38) Floorboards
- 9) Water tank
- 40) Hot water tank
