GF
1 CLARENDON CRESCENT
EDINBURGH
EH4 1PT

Home Report

Energy Performance Certificate (EPC)

Scottish Single Survey

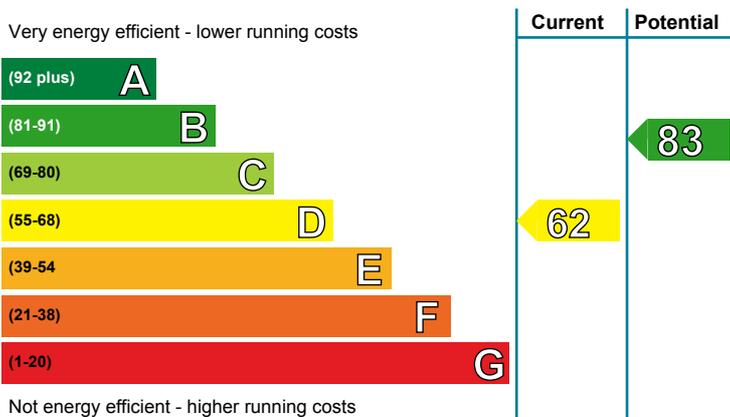
Energy Efficiency Rating

This graph shows the current efficiency of your home, taking into account both energy efficiency and fuel costs. The higher this rating, the lower your fuel bills are likely to be.

Your current rating is **band D (62)**. The average rating for EPCs in Scotland is **band D (61)**.

The potential rating shows the effect of undertaking all of the improvement measures listed within your recommendations report.

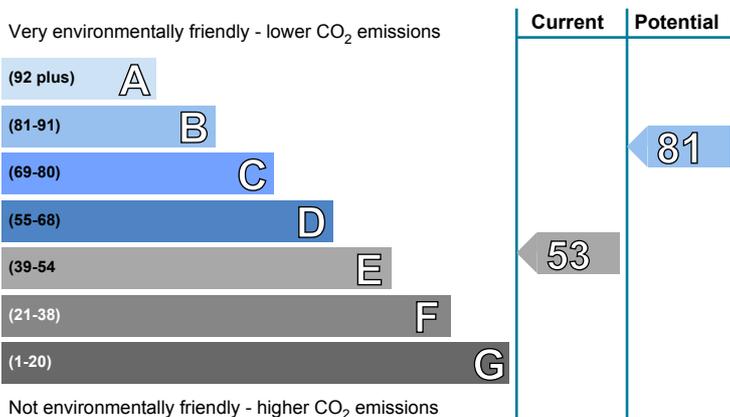
Environmental Impact (CO₂) Rating

This graph shows the effect of your home on the environment in terms of carbon dioxide (CO₂) emissions. The higher the rating, the less impact it has on the environment.

Your current rating is **band E (53)**. The average rating for EPCs in Scotland is **band D (59)**.

The potential rating shows the effect of undertaking all of the improvement measures listed within your recommendations report.
