Home Report

Braeriach
Urlar Road
Aberfeldy
PH15 2ET

single survey

Property address	Braeriach Urlar Road Aberfeldy PH15 2ET
Customer	Mr B & Mrs C Strickland
Prepared by	Greg Davidson

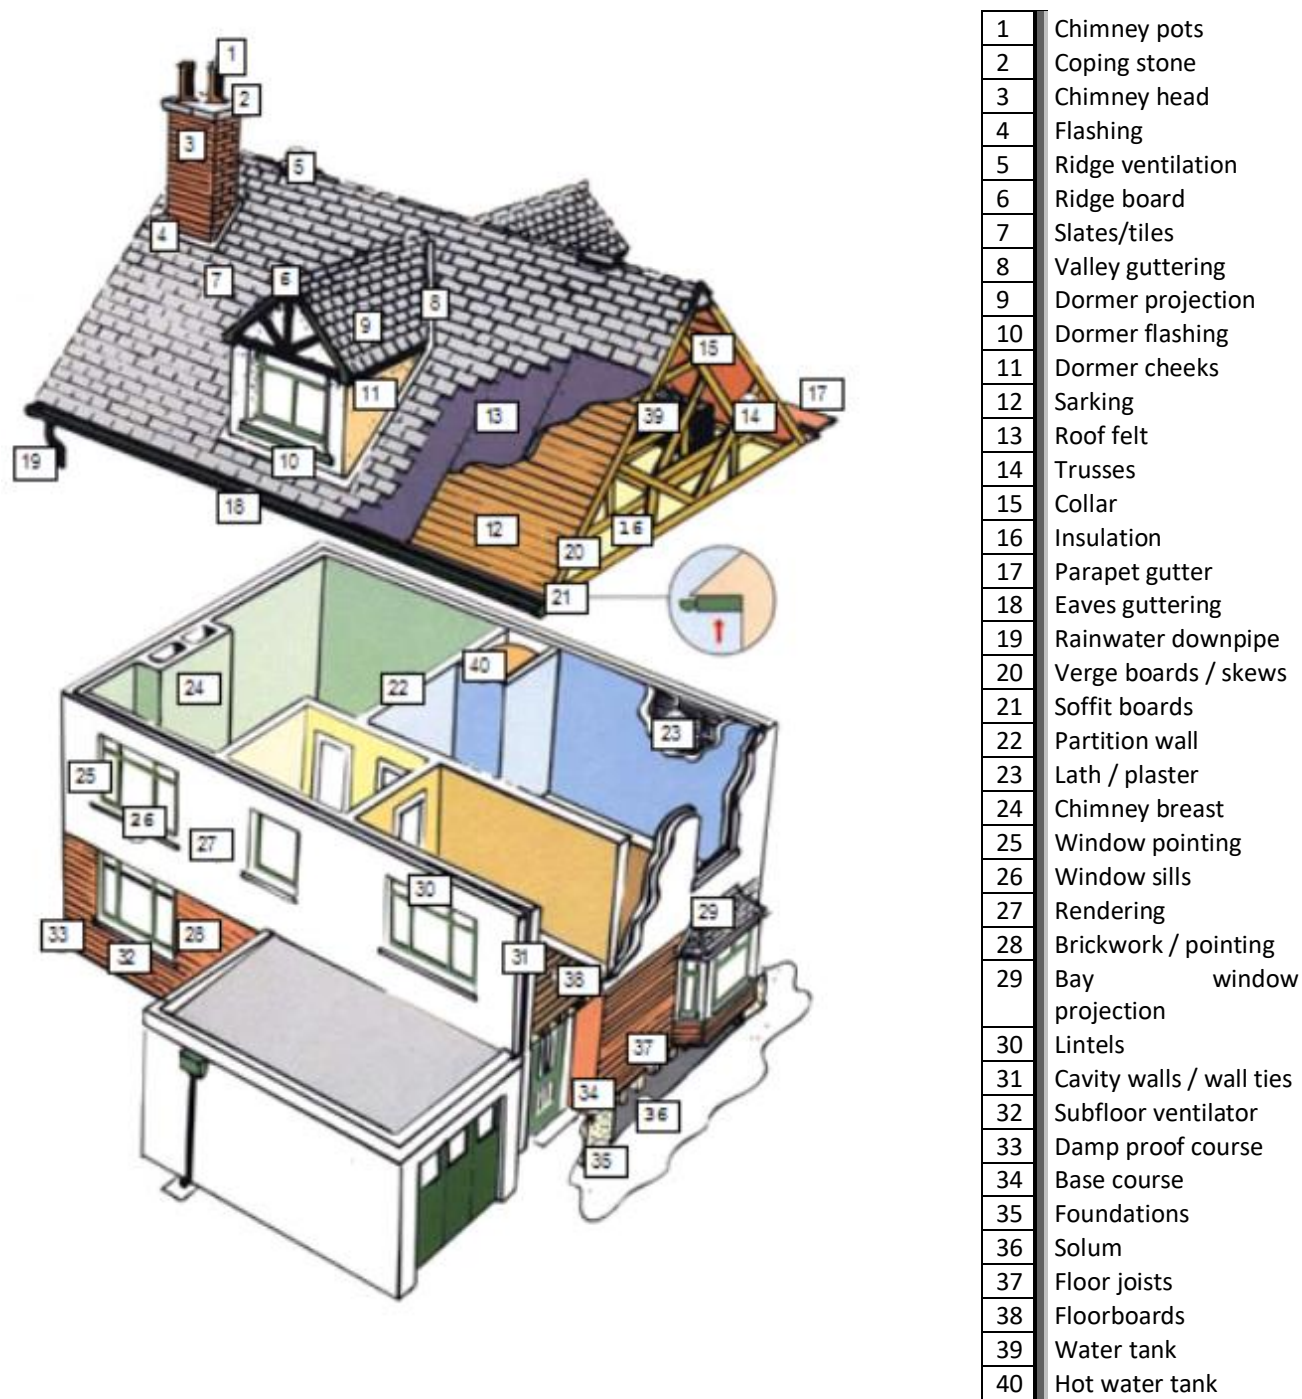
Sectional Diagram showing elements of a typical house

Reference may be made in this report to some or all of the above component parts of the property. This diagram may assist you in locating and understanding these items.
