# HOME REPORT

# Energy Performance Certificate (EPC)

FLAT 36 , 7 PORTLAND GARDENS, EDINBURGH, EH6 6NQ

# Single Survey

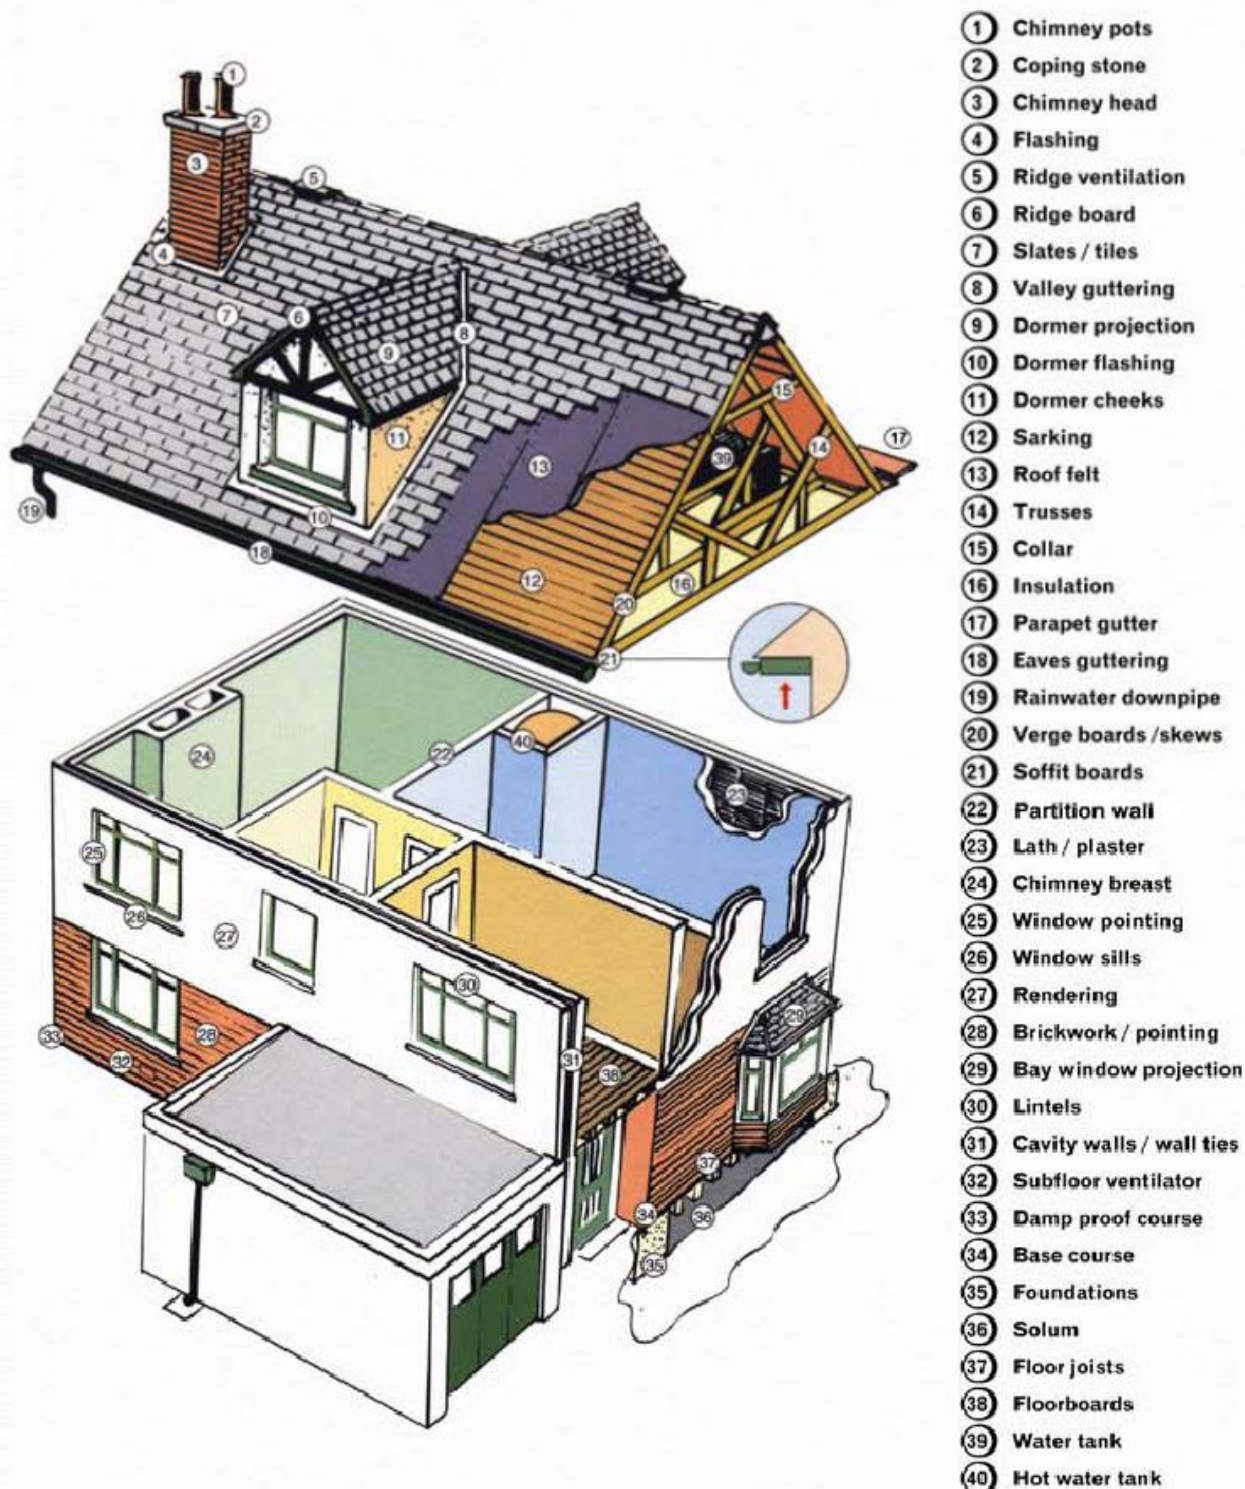
## Sectional Diagram showing elements of a typical house

Reference may be made in this report to some or all of the above component parts of the property. This diagram may assist you in locating and understanding these items.
