YOUR ONE SURVEY  
**HOME REPORT**

Lismore House  
115 Kelvin Drive  
Glasgow  
G20 8QL

# SINGLE SURVEY

# Single Survey

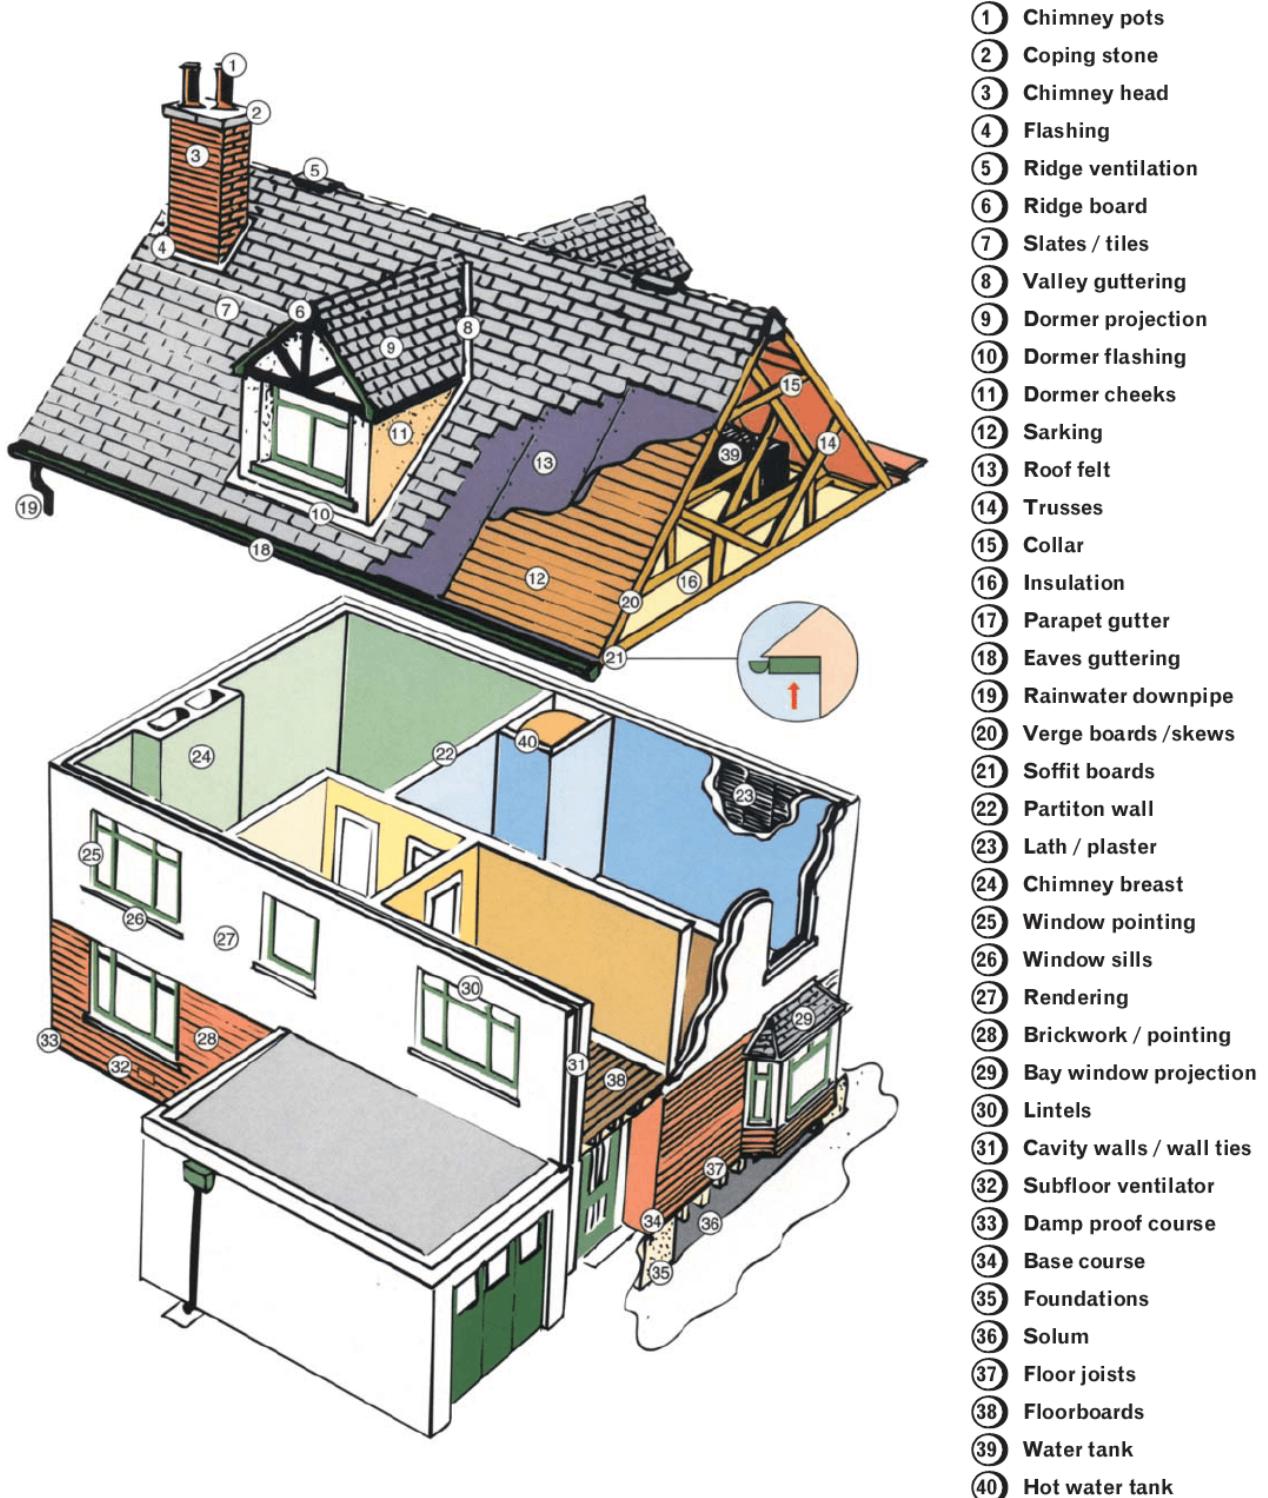
## Sectional Diagram showing elements of a typical house

Reference may be made in this report to some or all of the above component parts of the property. This diagram may assist you in locating and understanding these items.

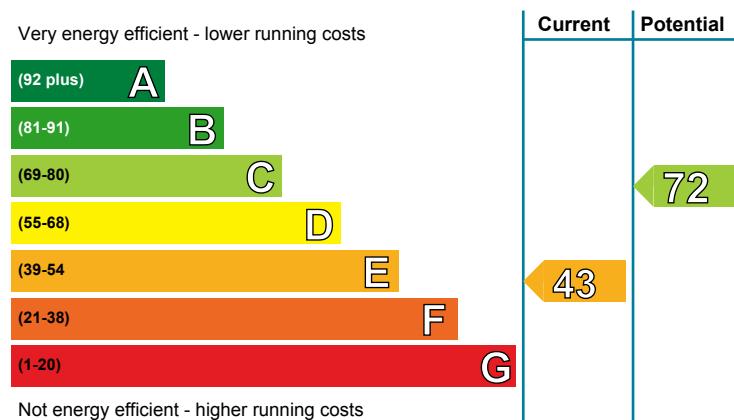
## Energy Efficiency Rating

This graph shows the current efficiency of your home, taking into account both energy efficiency and fuel costs. The higher this rating, the lower your fuel bills are likely to be.

Your current rating is **band E (43)**. The average rating for EPCs in Scotland is **band D (61)**.

The potential rating shows the effect of undertaking all of the improvement measures listed within your recommendations report.

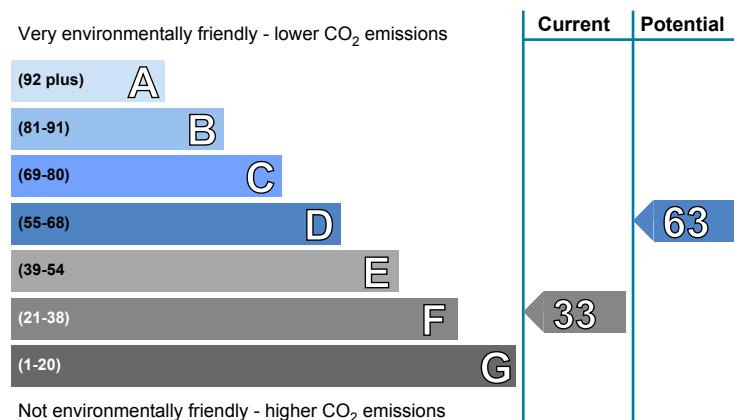
## Environmental Impact (CO<sub>2</sub>) Rating

This graph shows the effect of your home on the environment in terms of carbon dioxide (CO<sub>2</sub>) emissions. The higher the rating, the less impact it has on the environment.
