YOUR ONESURVEY
HOME REPORT

Flat 1/2
213 Wilton Street
Glasgow
G20 6DE

HOME REPORT

SINGLE SURVEY

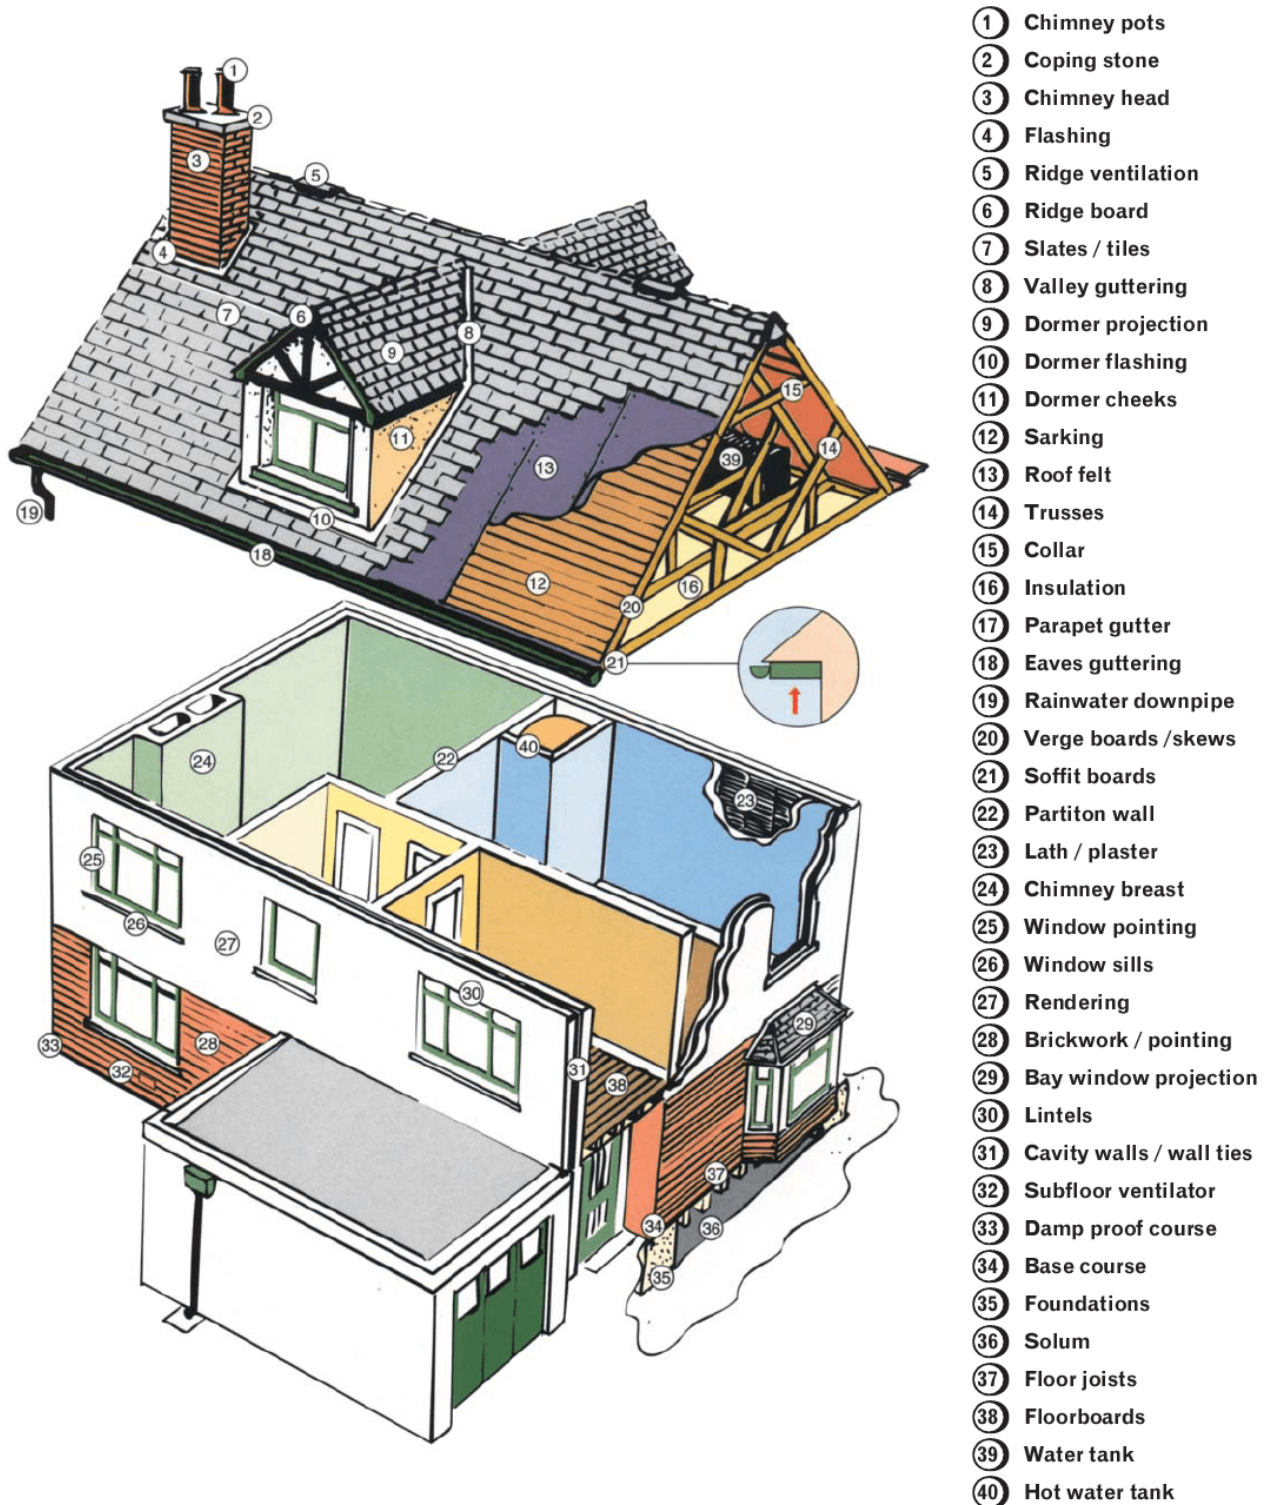
Sectional Diagram showing elements of a typical house

- ① Chimney pots
- ② Coping stone
- ③ Chimney head
- ④ Flashing
- ⑤ Ridge ventilation
- ⑥ Ridge board
- ⑦ Slates / tiles
- ⑧ Valley guttering
- ⑨ Dormer projection
- ⑩ Dormer flashing
- ⑪ Dormer cheeks
- ⑫ Sarking
- ⑬ Roof felt
- ⑭ Trusses
- ⑮ Collar
- ⑯ Insulation
- ⑰ Parapet gutter
- ⑱ Eaves guttering
- ⑲ Rainwater downpipe
- ⑳ Verge boards /skews
- ㉑ Soffit boards
- ㉒ Partiton wall
- ㉓ Lath / plaster
- ㉔ Chimney breast
- ㉕ Window pointing
- ㉖ Window sills
- ㉗ Rendering
- ㉘ Brickwork / pointing
- ㉙ Bay window projection
- ㉚ Lintels
- ㉛ Cavity walls / wall ties
- ㉜ Subfloor ventilator
- ㉝ Damp proof course
- ㉞ Base course
- ㉟ Foundations
- ㊱ Solum
- ㊲ Floor joists
- ㊳ Floorboards
- ㊴ Water tank
- ㊵ Hot water tank

Reference may be made in this report to some or all of the above component parts of the property. This diagram may assist you in locating and understanding these items.
