YOUR ONESURVEY
HOME REPORT

93/6
Comely Bank Avenue
Edinburgh
EH4 1EU

SINGLE SURVEY

Single Survey

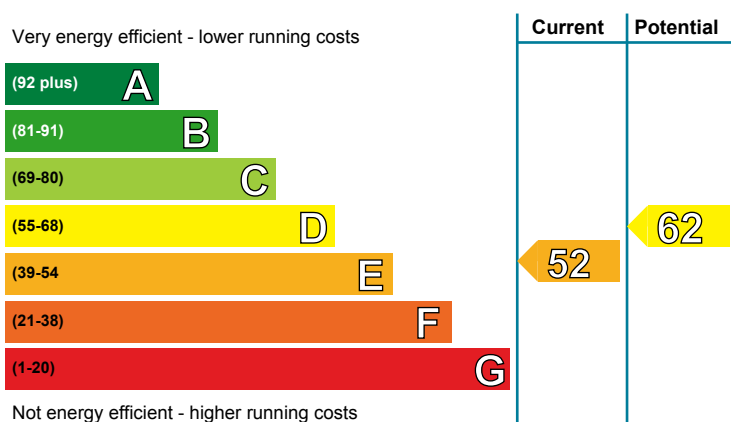
Energy Efficiency Rating

This graph shows the current efficiency of your home, taking into account both energy efficiency and fuel costs. The higher this rating, the lower your fuel bills are likely to be.

Your current rating is **band E (52)**. The average rating for EPCs in Scotland is **band D (61)**.

The potential rating shows the effect of undertaking all of the improvement measures listed within your recommendations report.

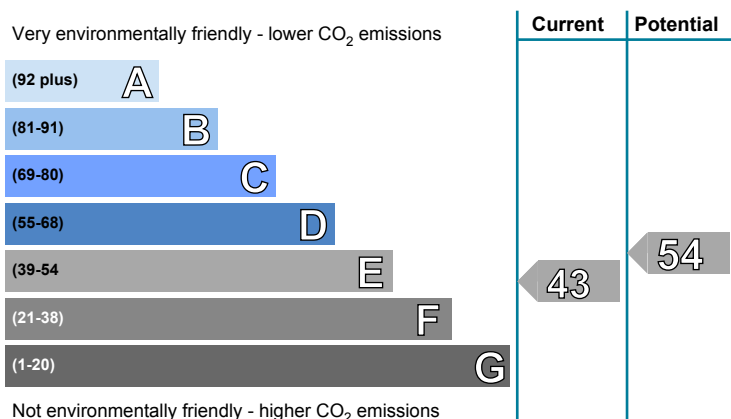
Environmental Impact (CO₂) Rating

This graph shows the effect of your home on the environment in terms of carbon dioxide (CO₂) emissions. The higher the rating, the less impact it has on the environment.
