FARMHOUSE AMISFIELD MAINS

Home Report

Energy Performance Certificate

Scottish Single Survey

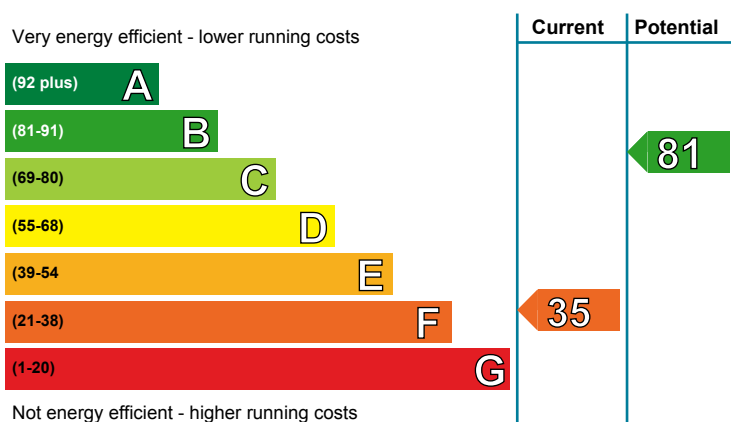
Energy Efficiency Rating

This graph shows the current efficiency of your home, taking into account both energy efficiency and fuel costs. The higher this rating, the lower your fuel bills are likely to be.

Your current rating is **band F (35)**. The average rating for EPCs in Scotland is **band D (61)**.

The potential rating shows the effect of undertaking all of the improvement measures listed within your recommendations report.

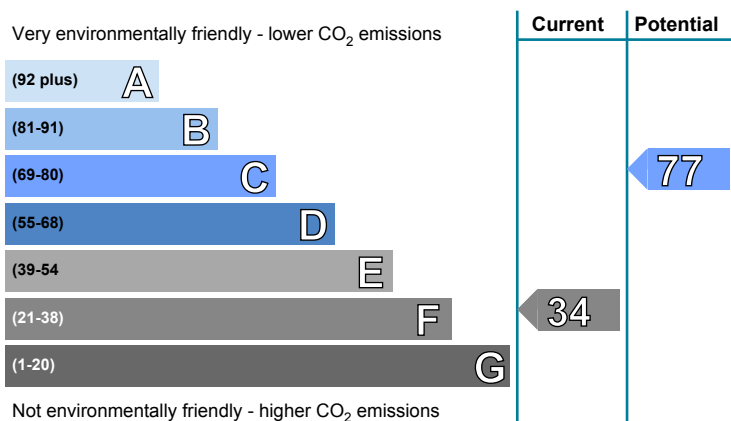
Environmental Impact (CO₂) Rating

This graph shows the effect of your home on the environment in terms of carbon dioxide (CO₂) emissions. The higher the rating, the less impact it has on the environment.

The potential rating shows the effect of undertaking all of the improvement measures listed within your recommendations report.
