YOUR ONESURVEY
HOME REPORT

White House
Main Road
Cardross
G82 5JY

Single Survey

Selling address	White House Main Road Cardross G82 5JY
------------------------	---

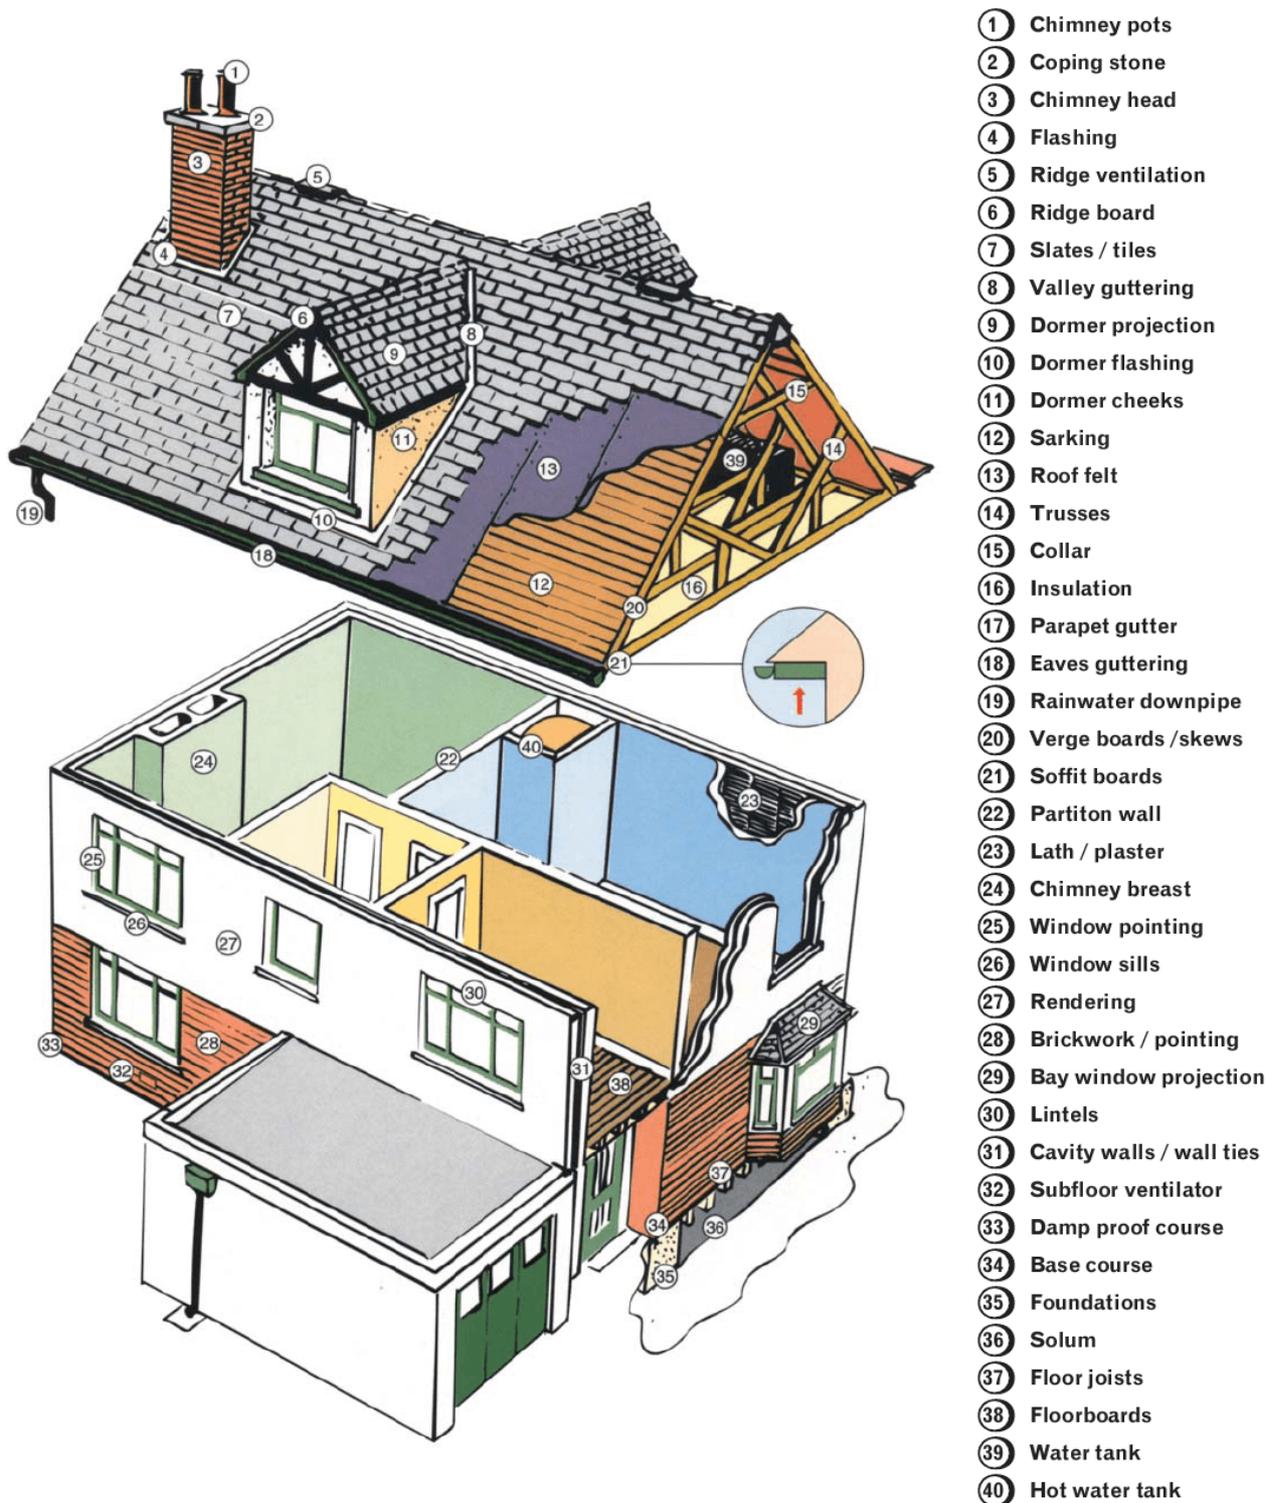
Sectional Diagram showing elements of a typical house

Reference may be made in this report to some or all of the above component parts of the property. This diagram may assist you in locating and understanding these items.

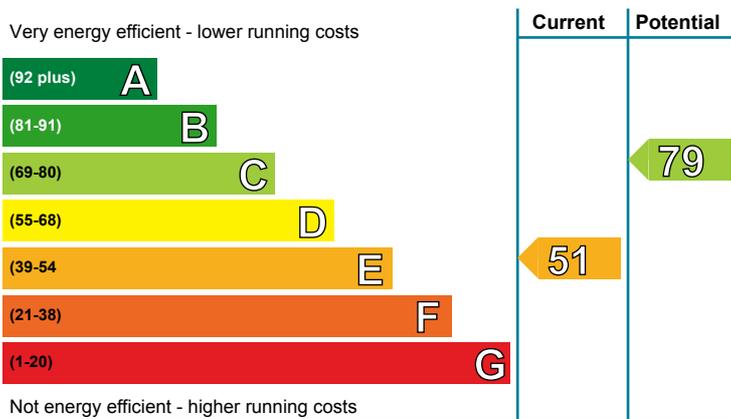
Energy Efficiency Rating

This graph shows the current efficiency of your home, taking into account both energy efficiency and fuel costs. The higher this rating, the lower your fuel bills are likely to be.

Your current rating is **band E (51)**. The average rating for EPCs in Scotland is **band D (61)**.

The potential rating shows the effect of undertaking all of the improvement measures listed within your recommendations report.

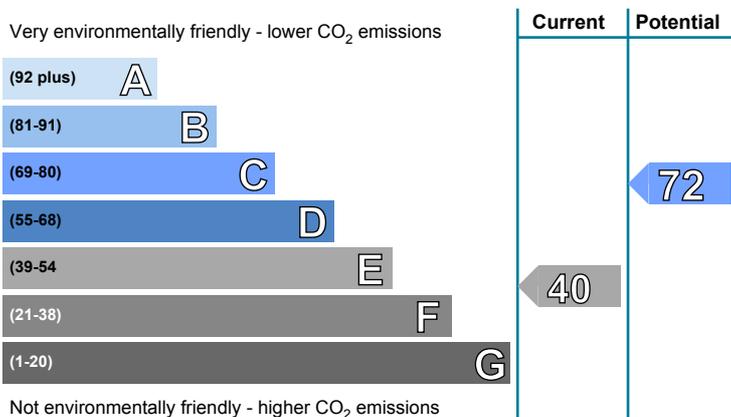
Environmental Impact (CO₂) Rating

This graph shows the effect of your home on the environment in terms of carbon dioxide (CO₂) emissions. The higher the rating, the less impact it has on the environment.
